# Manhole Inspection Summary

Manhole # S13EE1004MH

Insp Date: **1/26/09 1:24 PM**

**Location** Address: **4018 REISTERSTOWN RD** Cross Street: **SHIRLEY AVE**

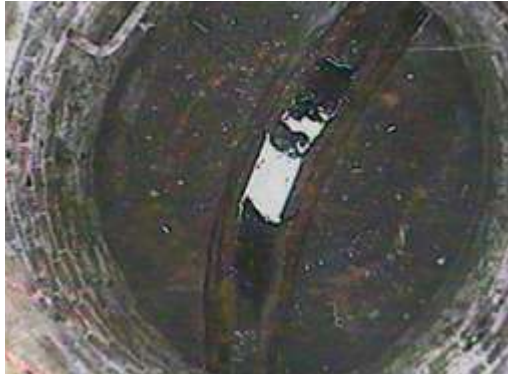
Defect 1

**Steps** Count: **3** Missing: **0** ☒ **Corroded**

CORRODED STEPS

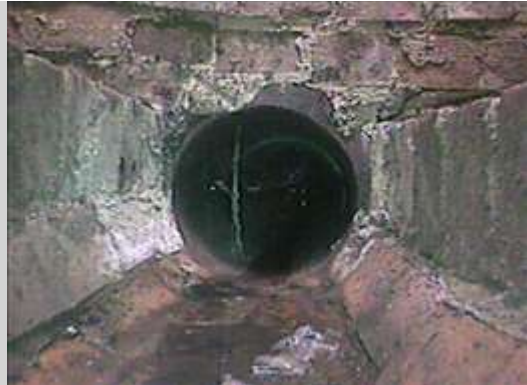
12 O'Clock Outflow

8 in. Circular Gravity Sewer  
Pipe Out @ 12 O'Clock

Pipe Material: **Clay** ☐ Pipe Lined

Invert Depth: **5.53** (ft.) Flow Characteristics: **None**

Infiltration: **None**

Pipe Seal Cond: **Sound**

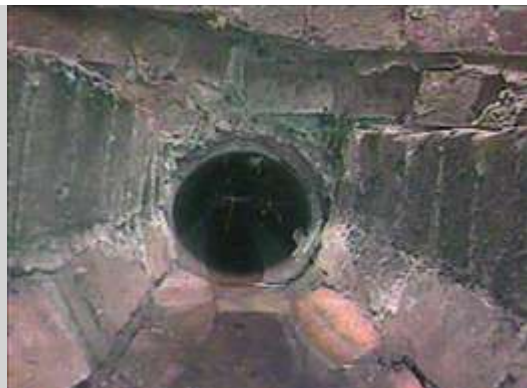
5 O'Clock Inflow

6 in. Circular Gravity Sewer  
Pipe In @ 5 O'Clock

Pipe Material: **Clay** ☐ Pipe Lined

Invert Depth: **5.54** (ft.) Flow Characteristics: **None**

Infiltration: **None**

Pipe Seal Cond: **Sound**
